CORRESPONDENCE/MEMORANDUM

SUBJECT: Concerns for the safety of staff at the Racine Air Monitoring Site.

Racine Air Monitoring Site

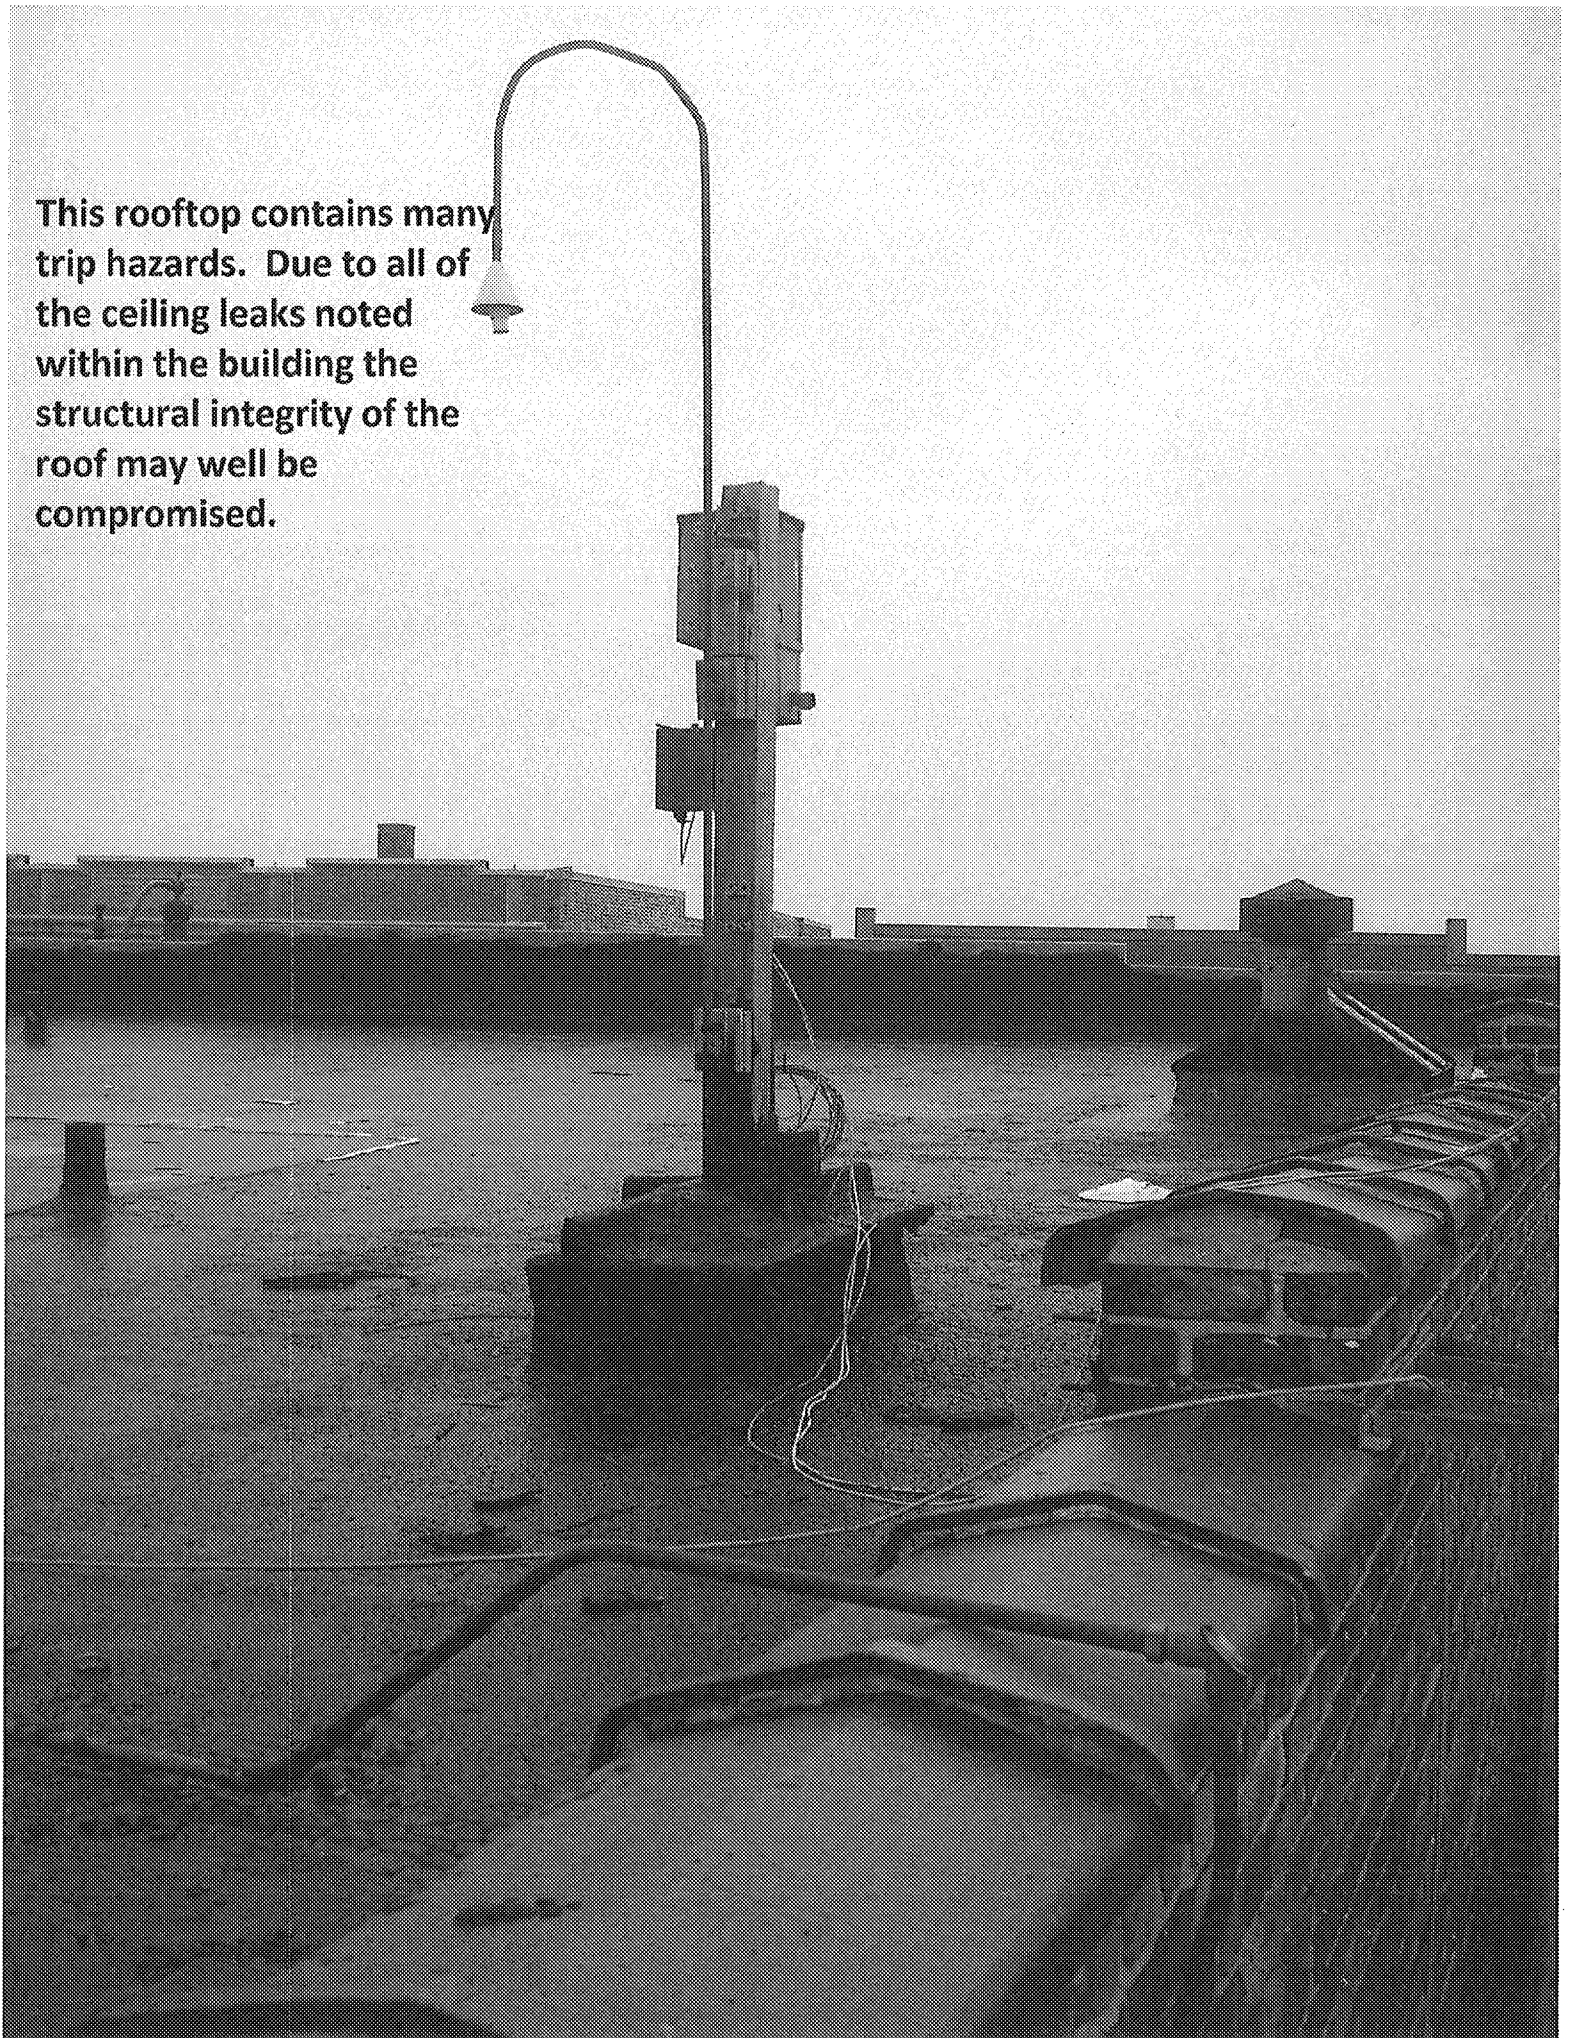
This rooftop contains many trip hazards. Due to all of the ceiling leaks noted within the building the structural integrity of the roof may well be compromised.

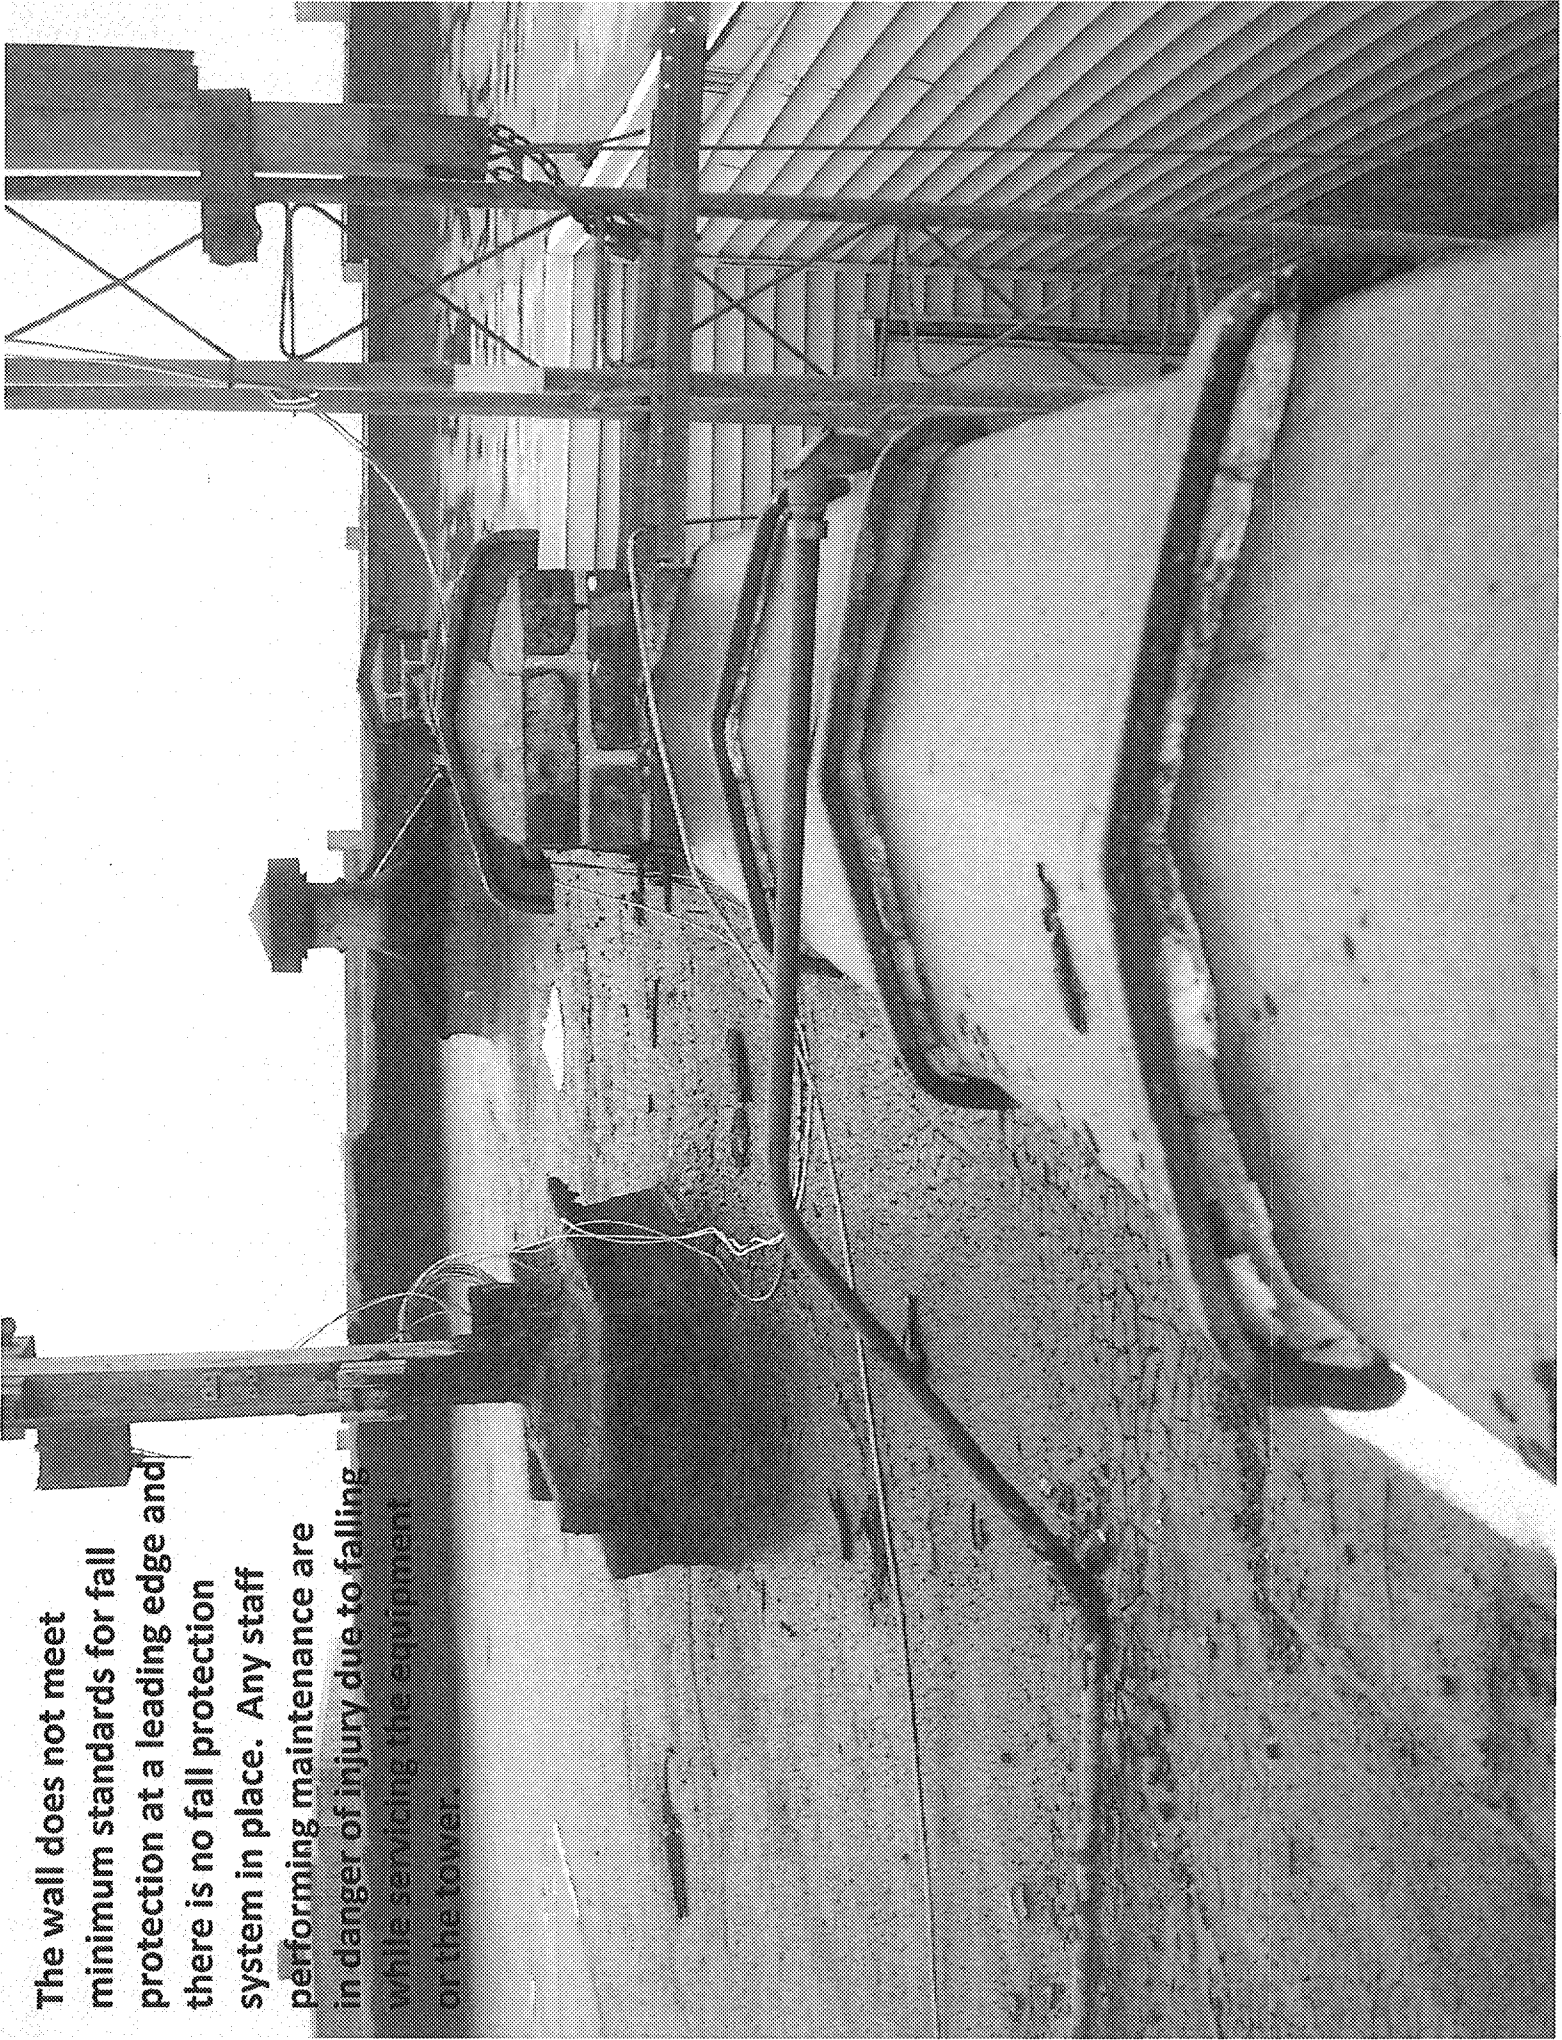
If access to the upper roof is made there is no fall protection in place, equipment is located near a leading edge with a parapet a foot or less above the edge. (See CFR 1926.501(b)(1) below) There are also numerous trip hazards. Rain and ice or snow can also create hazardous slippery conditions.

The wall does not meet minimum standards for fall protection at a leading edge and there is no fall protection system in place. Any staff performing maintenance are in danger of injury due to falling while servicing the equipment or the tower.

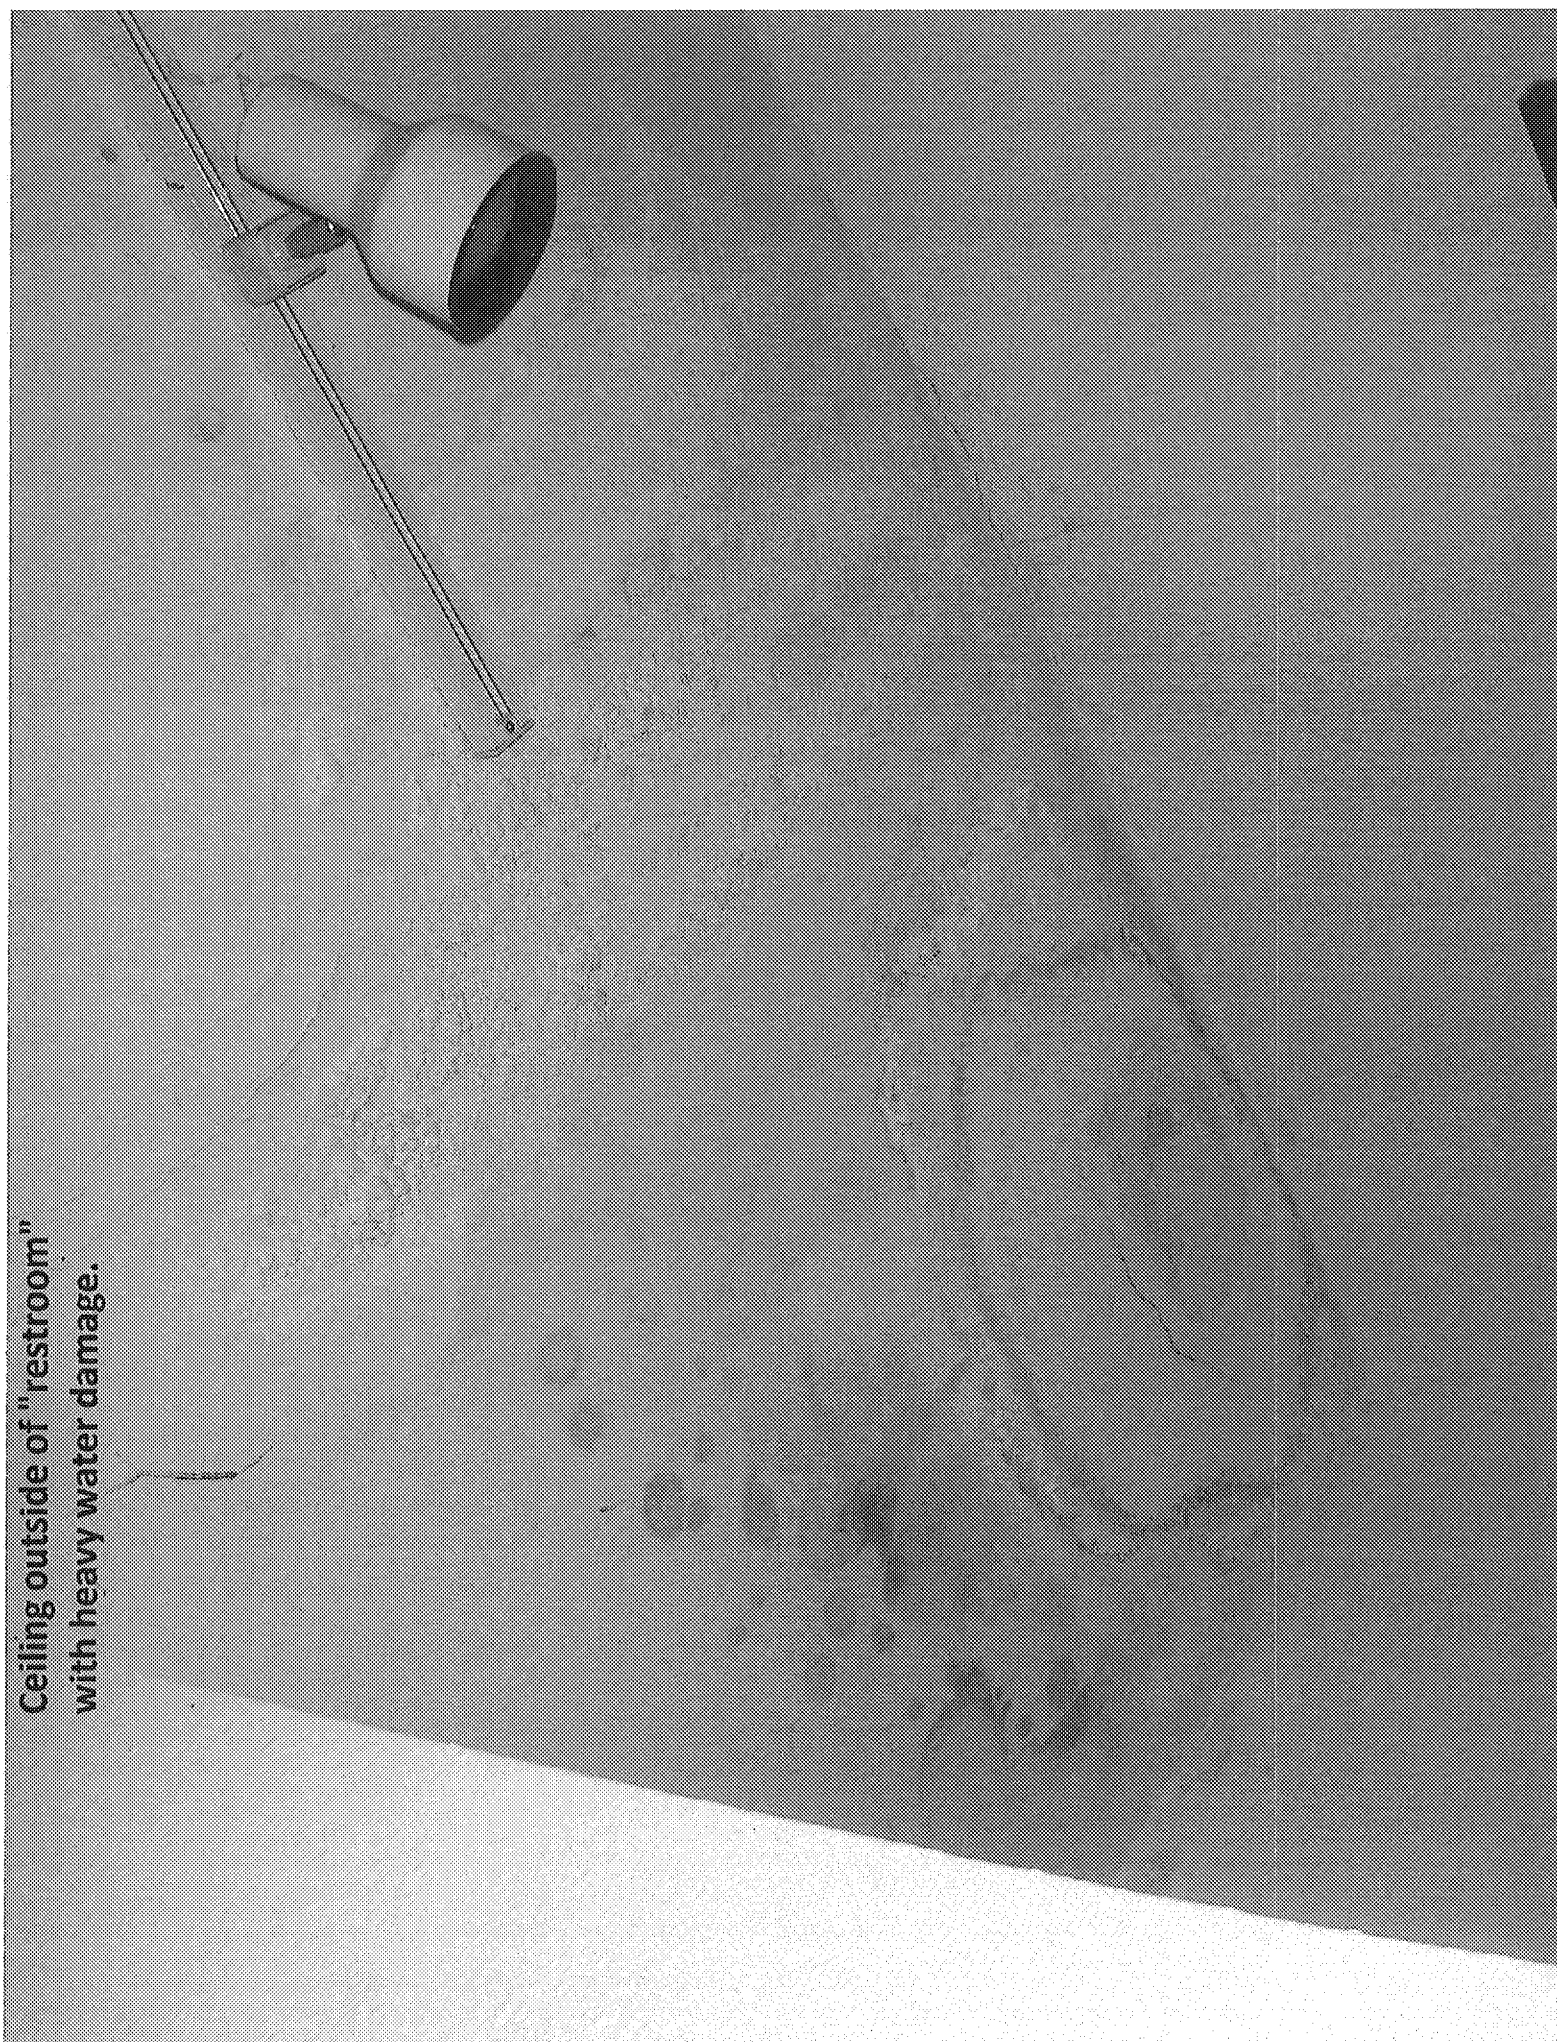
Ceiling outside of "restroom"
with heavy water damage.

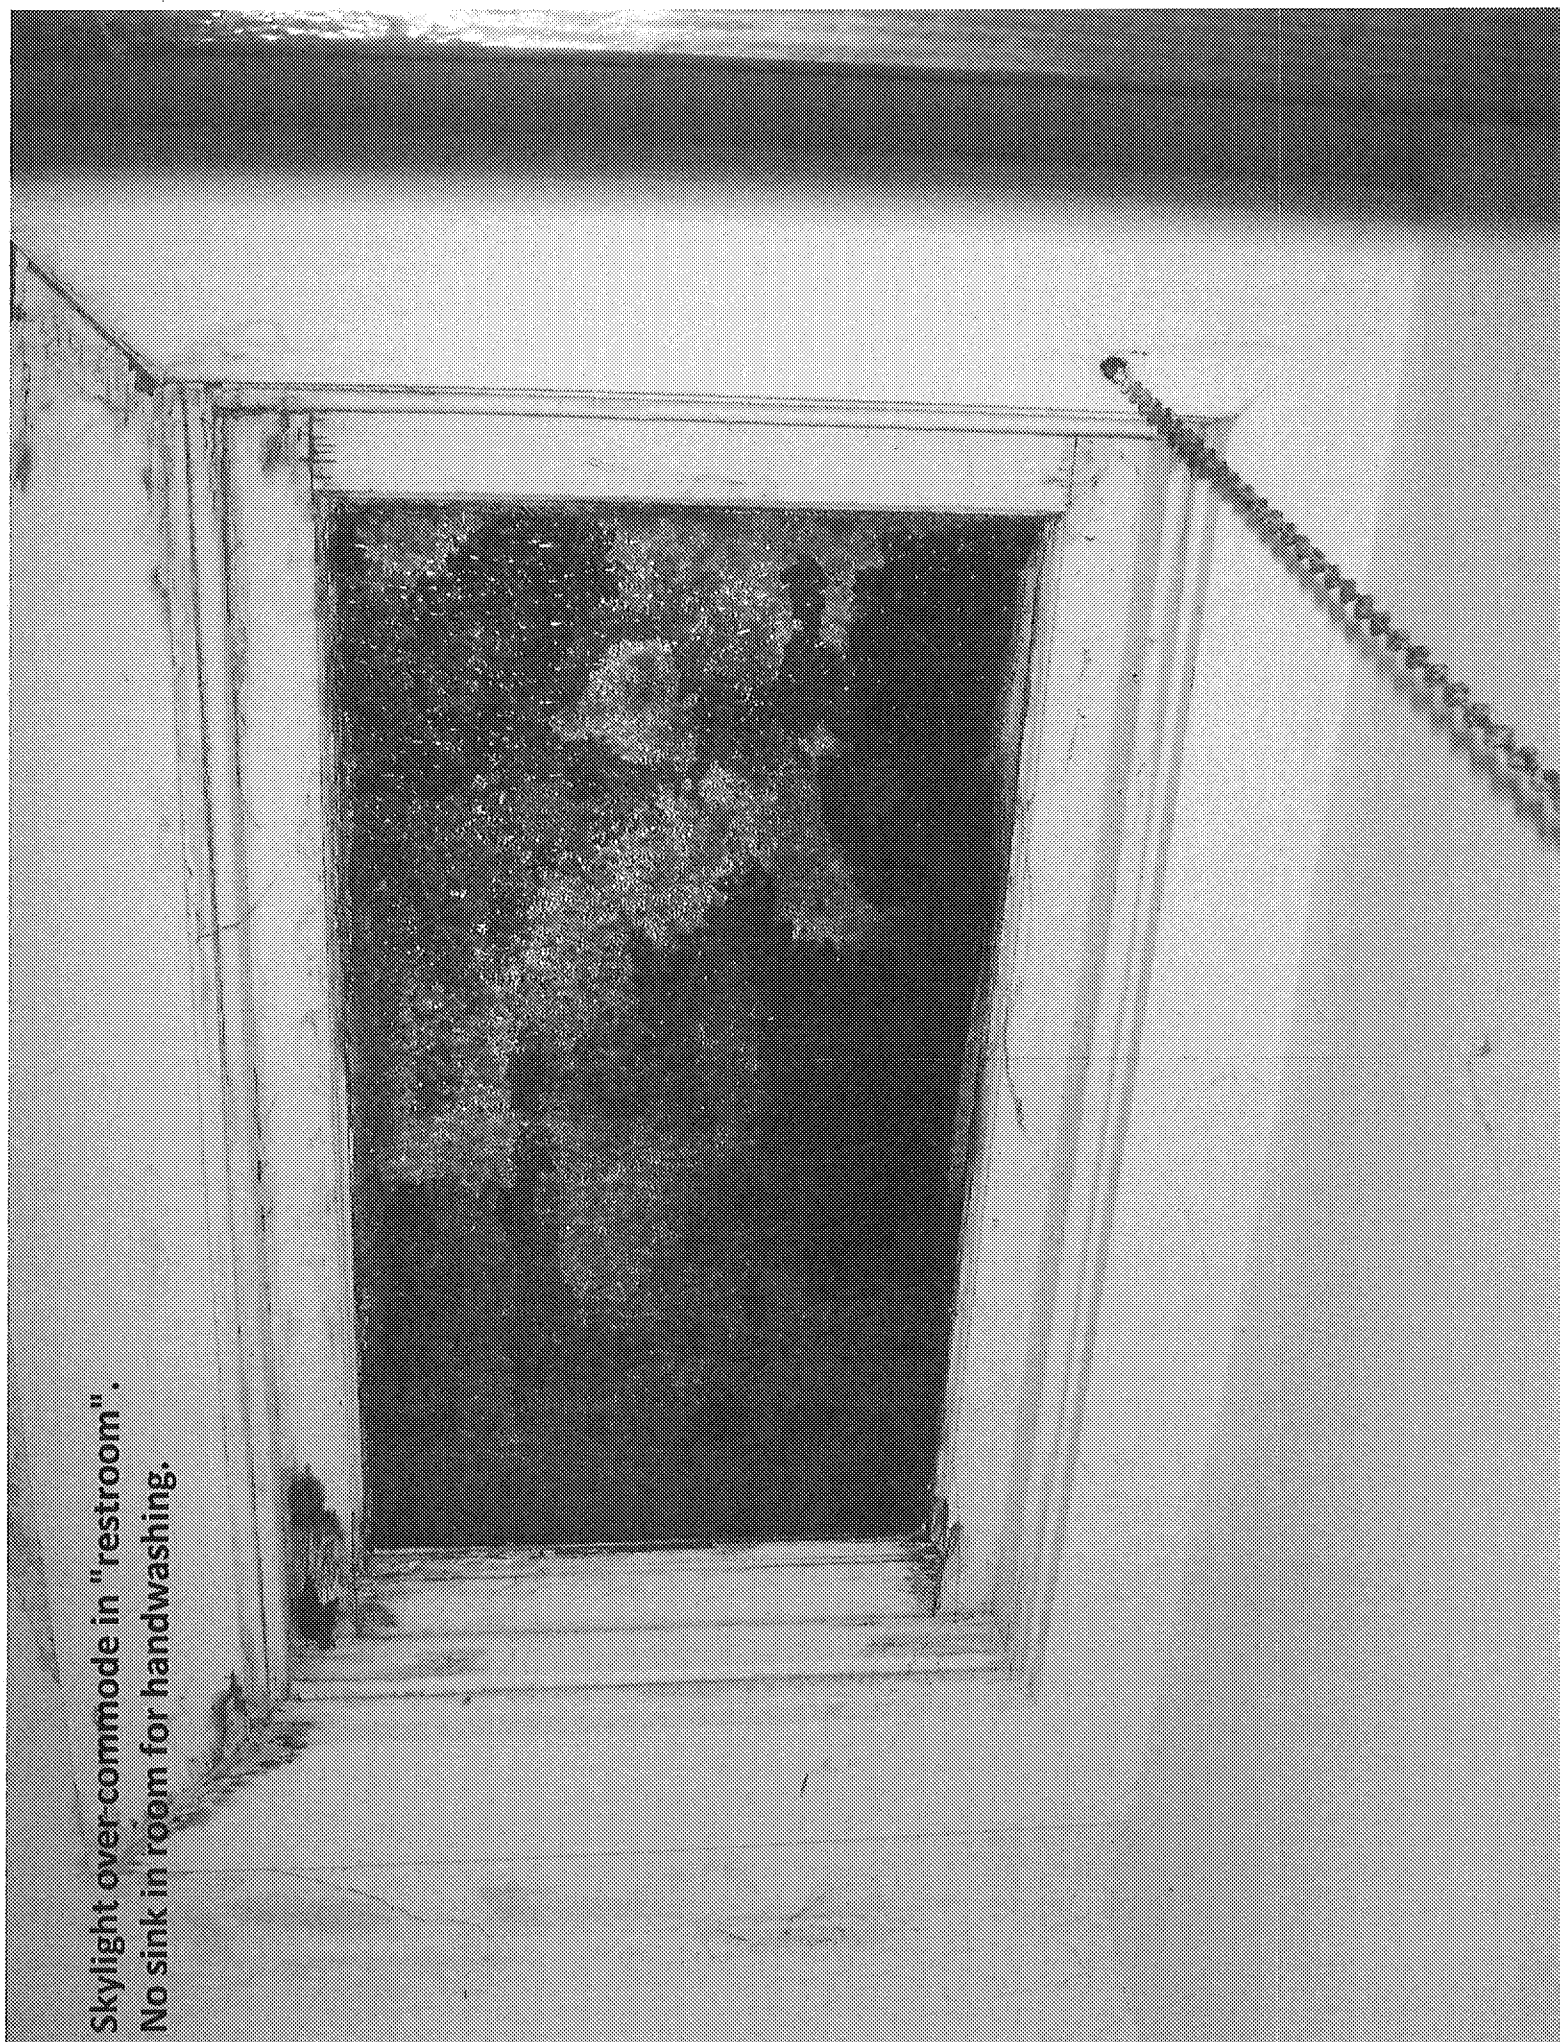
Skylight over commode in "restroom".
No sink in room for handwashing.

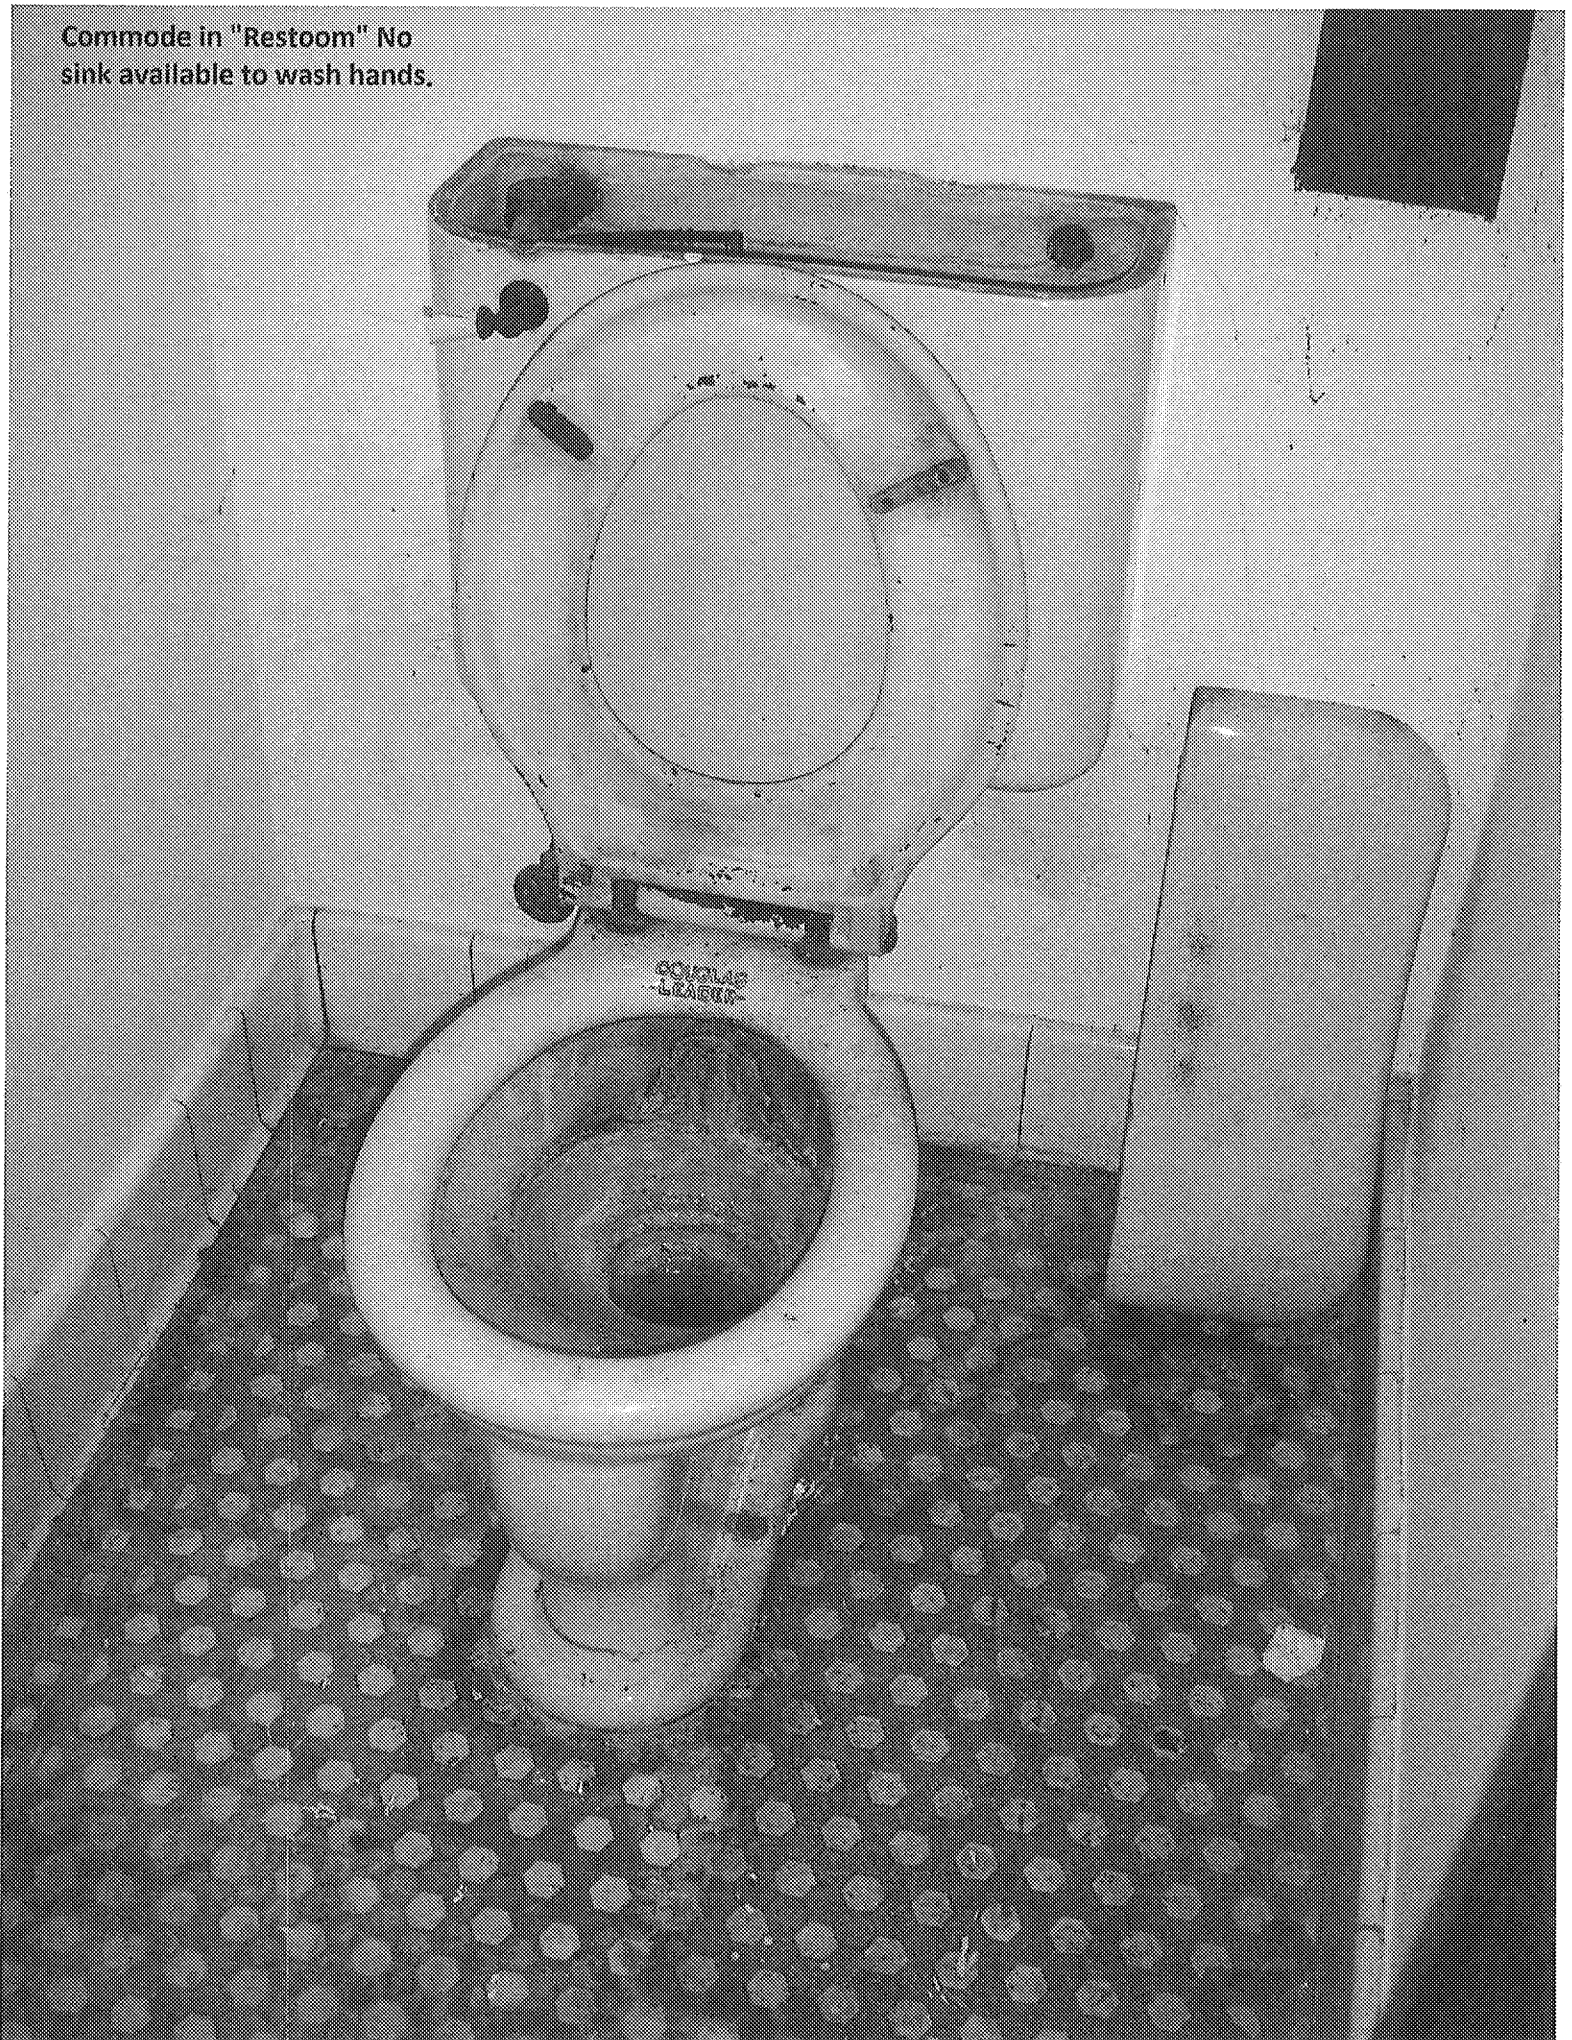
Commode in "Restoom" No
sink available to wash hands.
